# **OPERATING EXPERIENCE WEEKLY SUMMARY**

**Office of Nuclear and Facility Safety**

**November 6 - November 12, 1998**

**Summary 98-45**

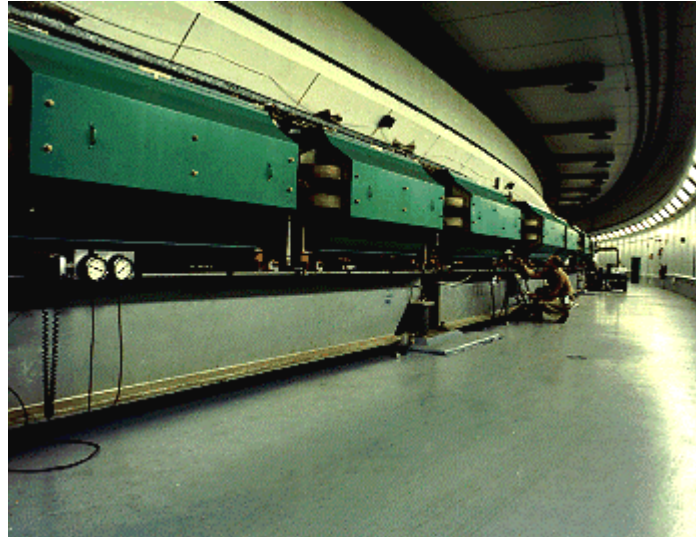
**Figure 2-1. The Alternating Gradient Synchrotron**

On November 5, 1998, at the Brookhaven National Laboratory Alternating Gradient Synchrotron (AGS), a worker entered the AGS ring, pictured in Figure 2-1, to look for an argon gas leak in the beam loss monitor system. The AGS was shut down when the worker entered under controlled access. When he heard the gas leak he began to look for the source. While he was pinpointing the leak, a portion of tubing came apart. He decided to reassemble the tubing. During the repair, he noticed a posting in the area indicating 7,400 mR/hr at 12". He immediately left the AGS ring and reported to a health physics technician. His self-reading dosimeter was off-scale high, indicating greater than 200 mR. The worker was forbidden to work in any radiation area until an evaluation is performed. The lack of adequate work planning resulted in the worker receiving a radiation dose that was greater than the AGS administrative control limit of 100 mR/day. (ORPS Report CH-BH-BNL-AGS-1998-0004)

A health physics technician surveyed the area where the work was performed. The survey indicated that the radiation level in the area was 5,000 mR/hr. Investigators estimate that exposure to the technician was approximately 400 mR, based on the technician's estimate of 5 minutes as the time to locate the leak and perform the repair. The personnel dosimetry group processed the technician's thermoluminescent dosimeter and determined that he received 180 mR during the incident.

These events underscore the importance of adequate work planning. They also underscore the need for adhering to radiological protection procedures. Facility managers should review the following guidance and should ensure that it is applied before beginning work.
